TECHNICAL REPORT ARLCD-TR-85003

**INVESTIGATION OF DAMAGED LANDS OF M185 CANNON
MOUNTED ON THE 155-MM M109A1 HOWITZER**

JUNE 1985

U.S. ARMY ARMAMENT RESEARCH AND DEVELOPMENT CENTER

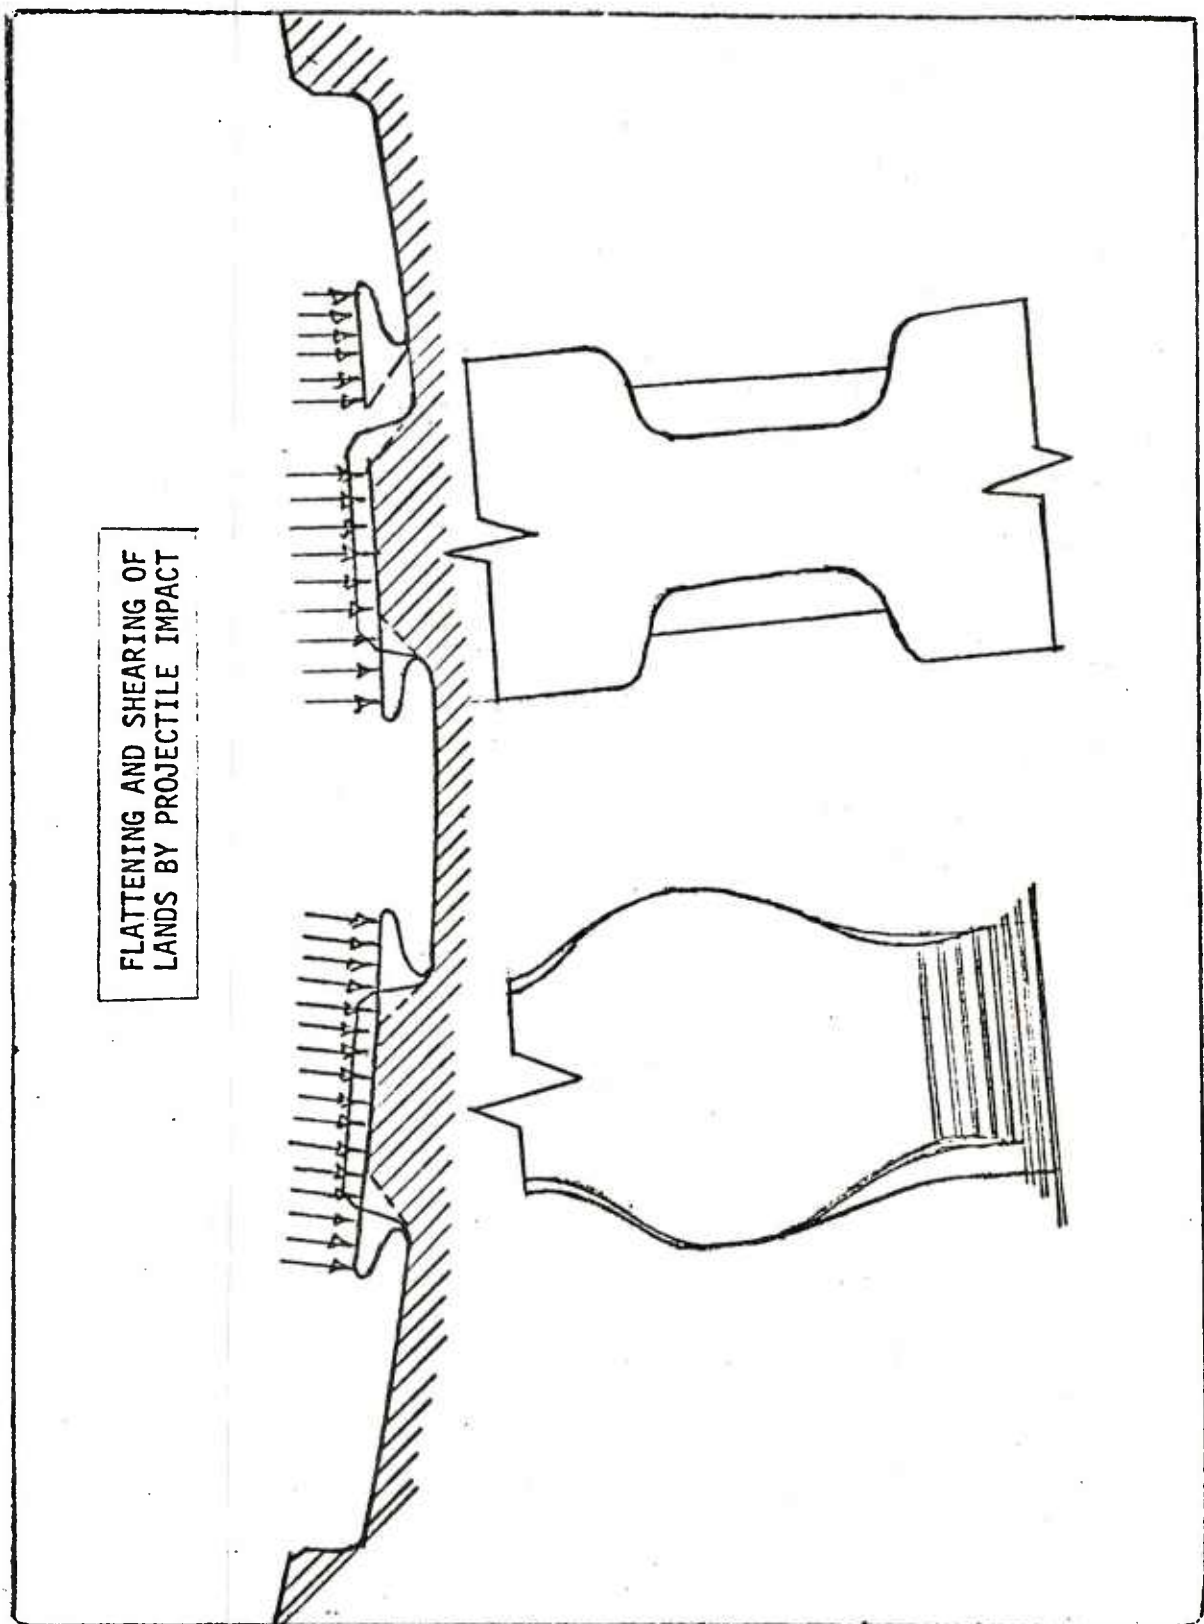
Figure 6. Mechanism of land stripping--fragments sheared down

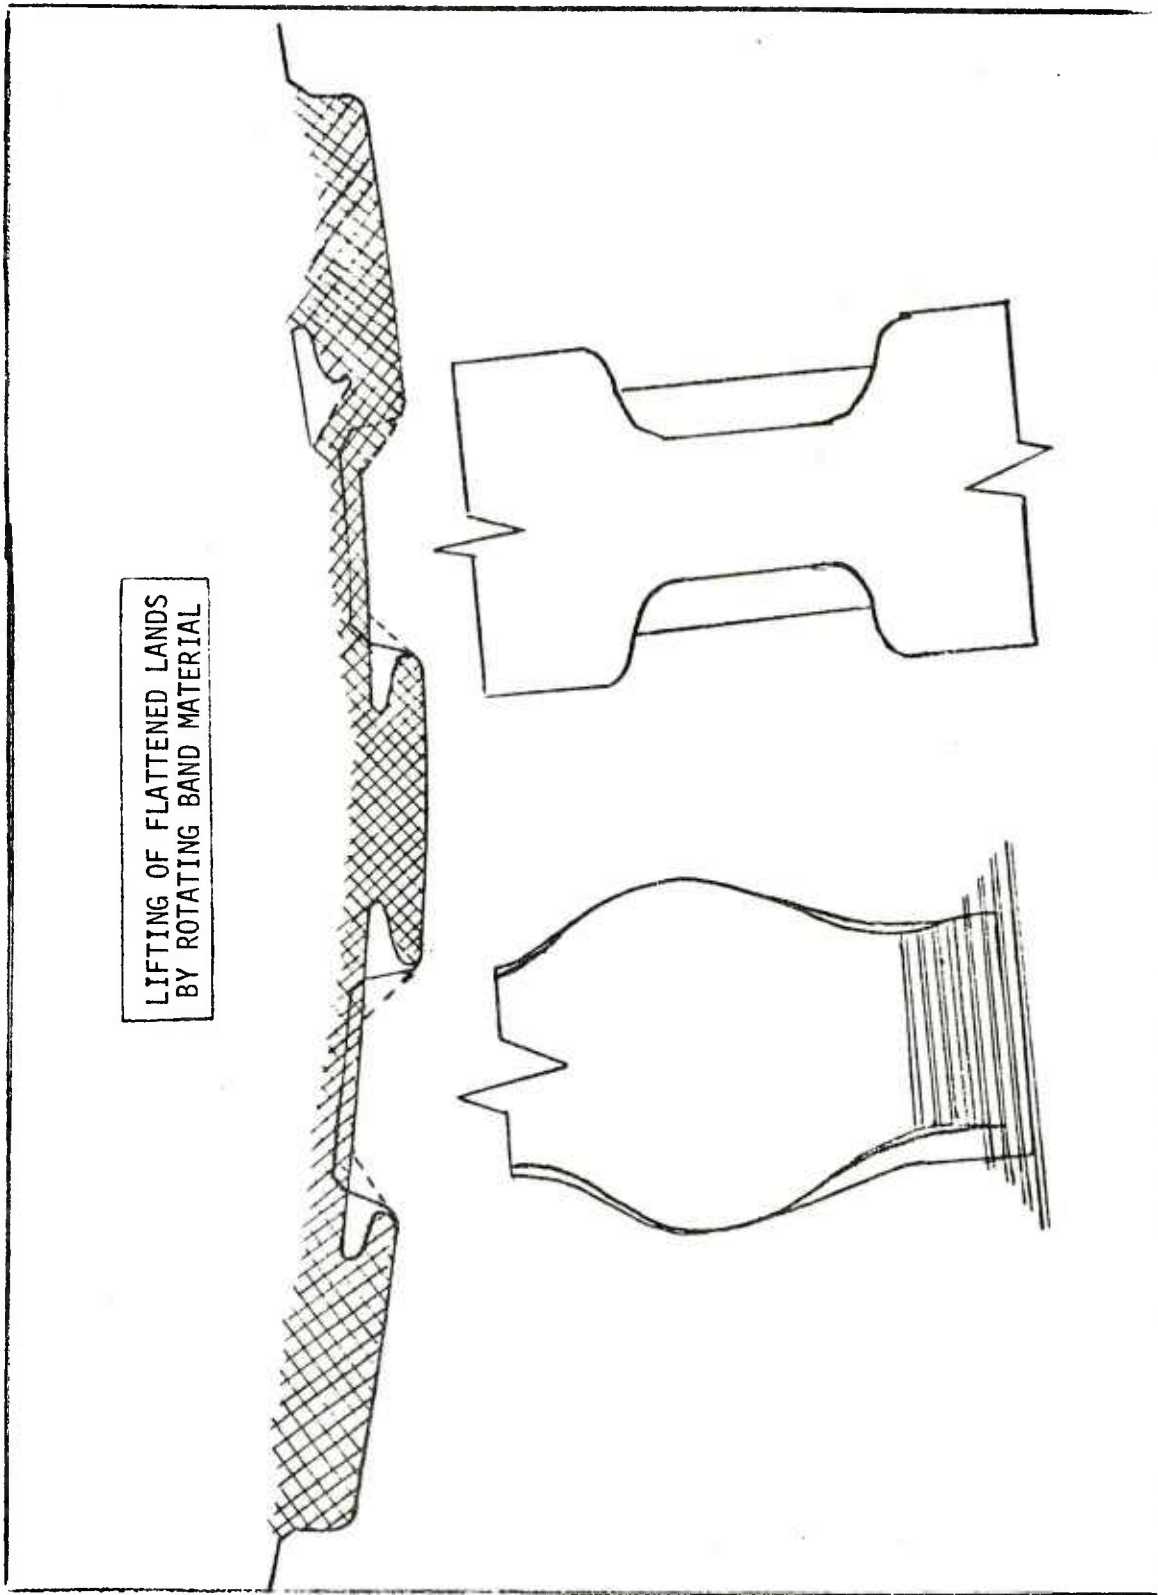
Figure 7. Mechanism of land stripping--fragments lifted

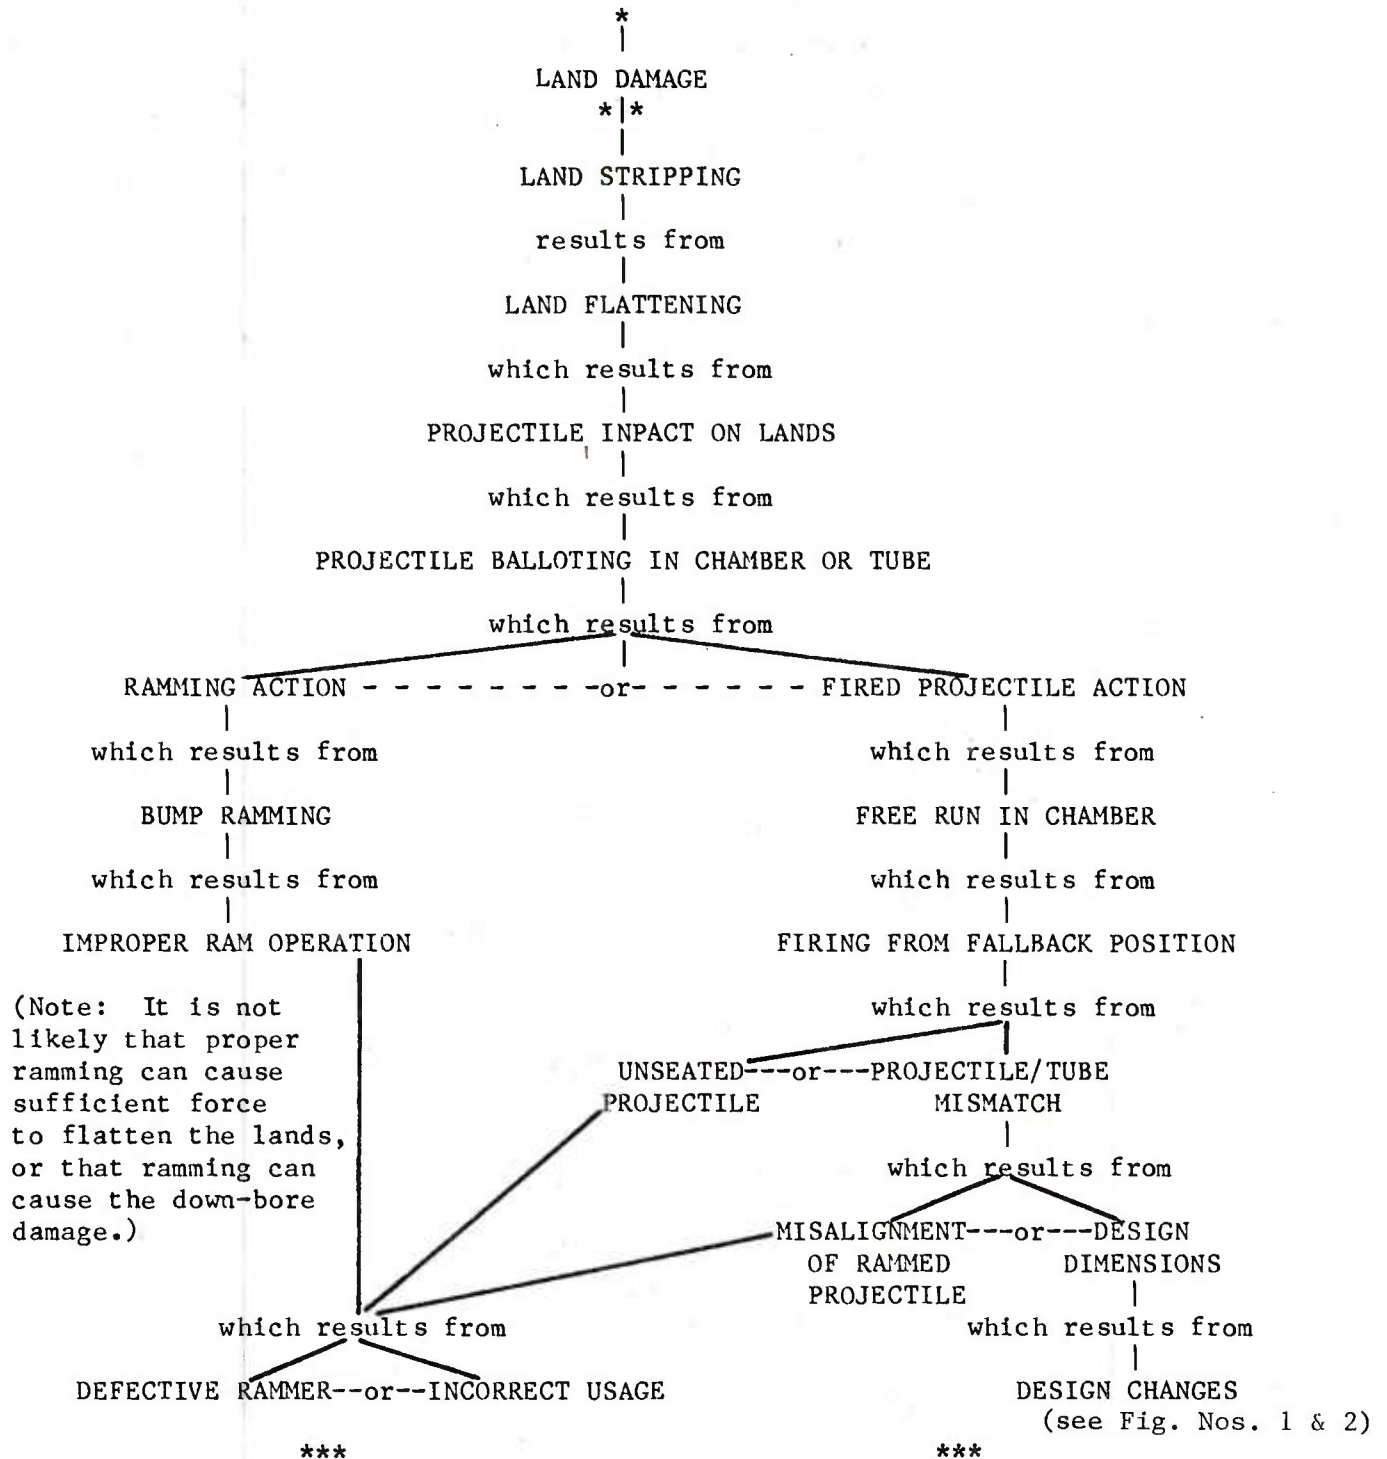
Figure 8. Land damage fault tree

Consonant with these observations, a land damage fault tree was constructed (fig. 8).

The root cause in this fault tree appears to be either in the dimensions of the rotating band/forcing cone or in the operation of the rammer.

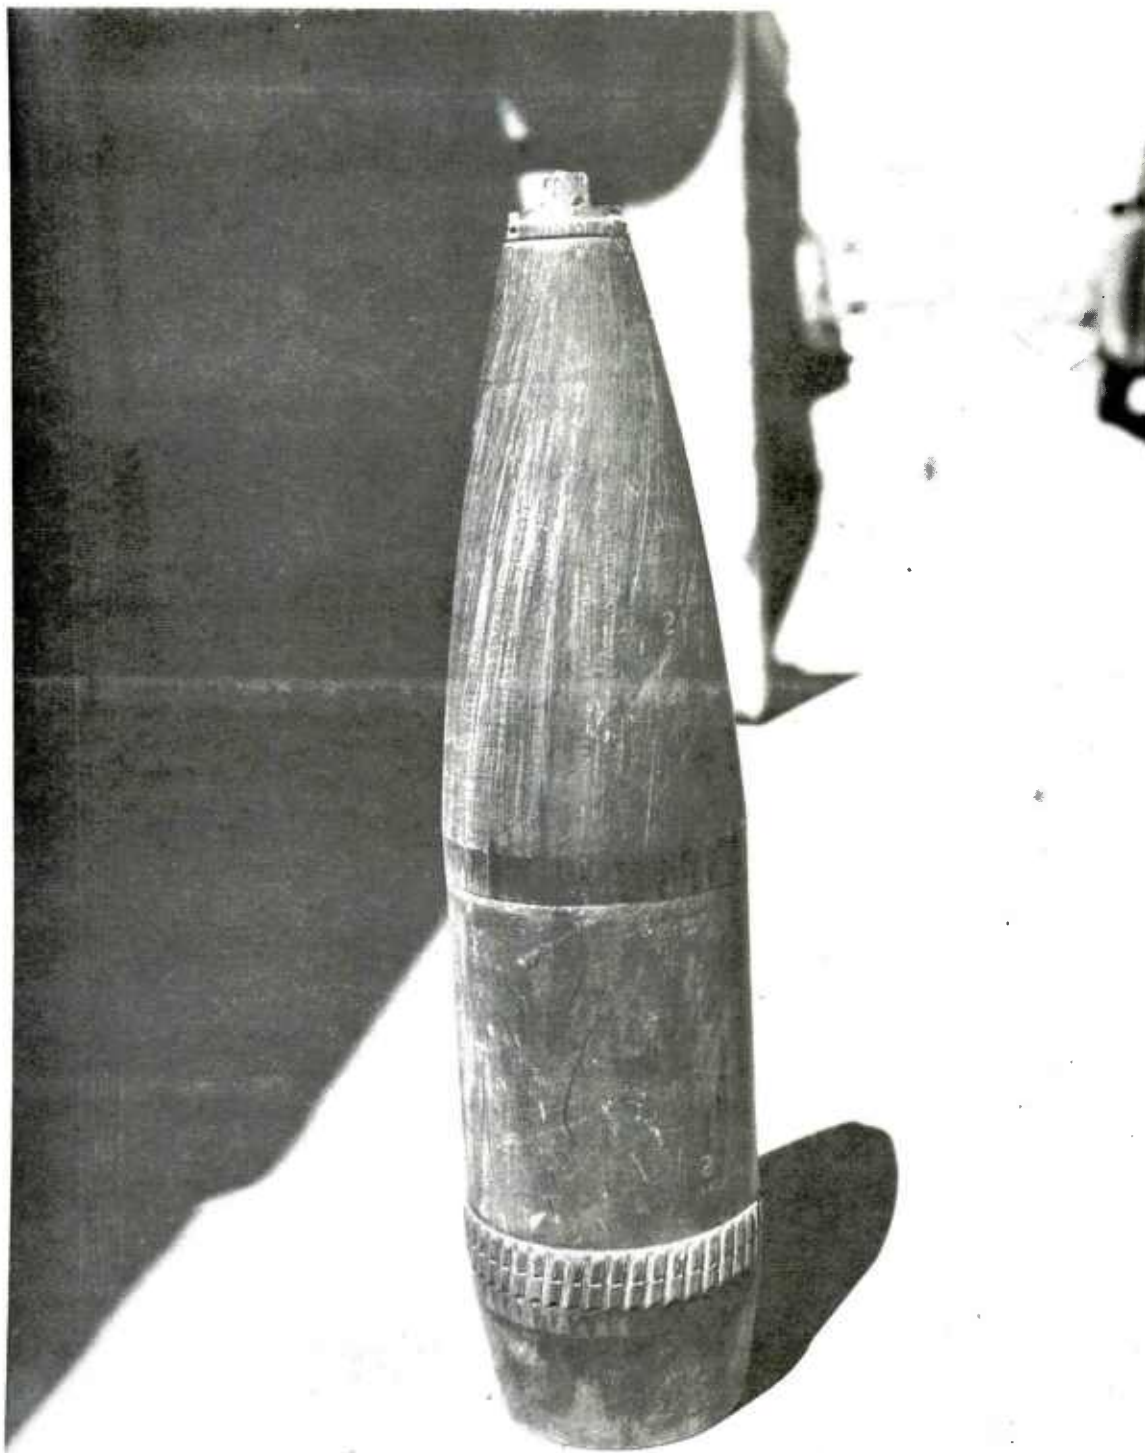
b. Projectile 2 fired 31 March 1981

Figure 10. (cont)

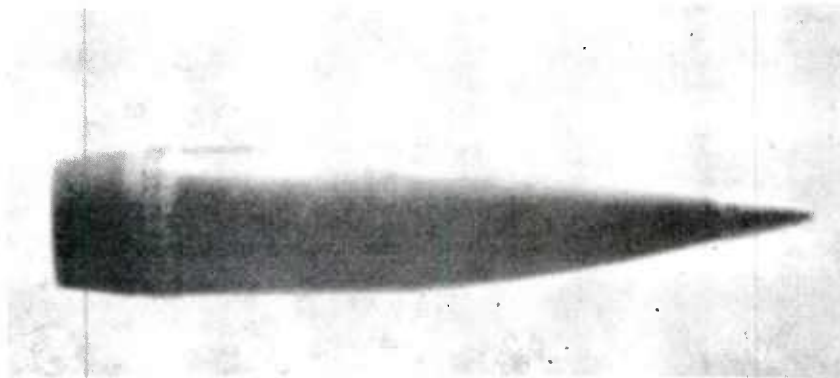
Tube No. 28317, Tube Round No. 13

View of projectile which showed no
abnormalities in the smear photographs.

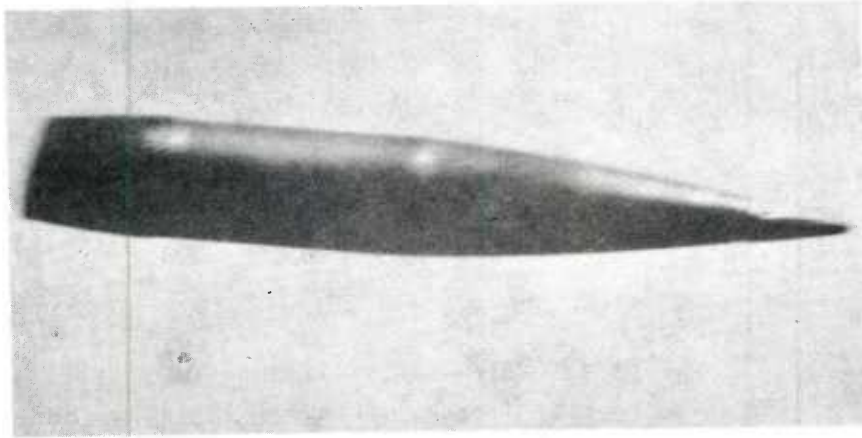
Round No. 4 fired from
tube No. 28317 showing
projectile instability
near the muzzle.

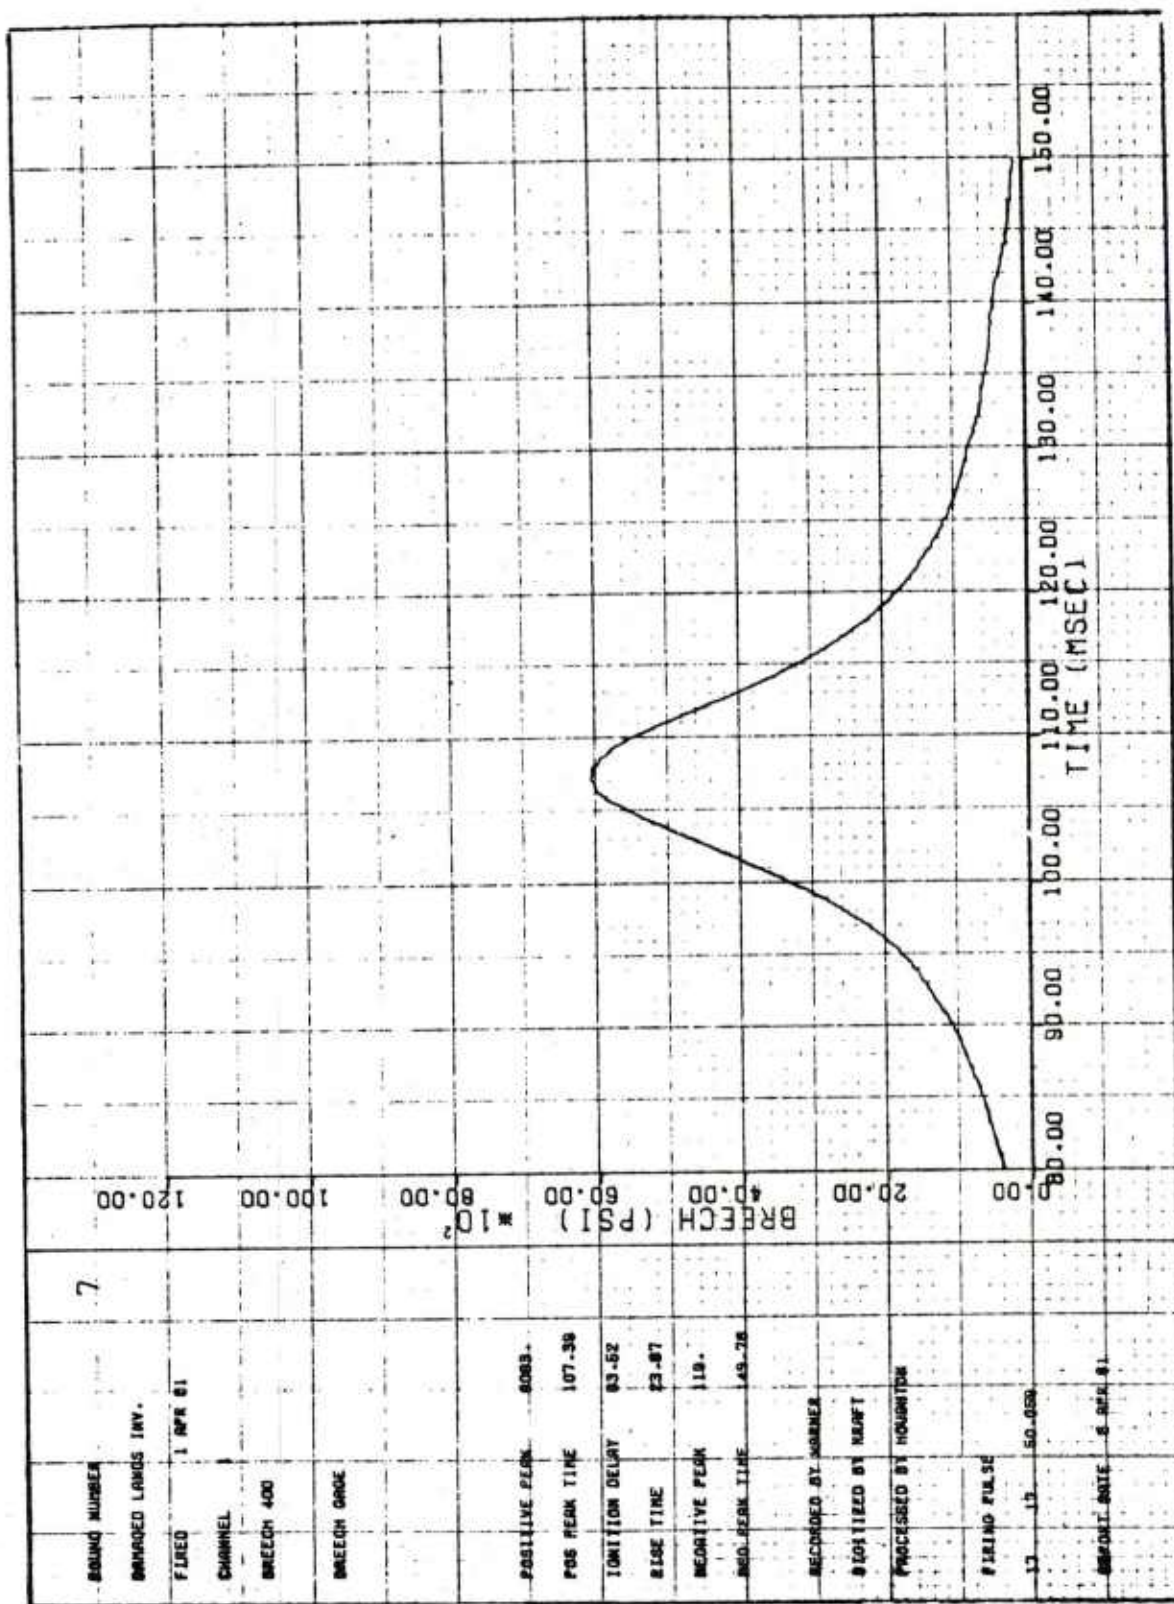
a. Breech--round 7

Sample breech and chamber pressure curves are provided in figures 15a through 15k. A comparison of peak pressure values for rounds 7 and 8 (figs. 15a and 15b) revealed a 1/3 drop in magnitude for equivalent ammunition in an identical weapon. This demonstrates the wide unpredictable variations in the ballistics of "fallback" firings (in this case, with an M4A2 zone 4 charge, the instantaneous projectile velocity for round 7 was 266.1 m/s whereas for round 8, it was 194.0 m/s). This dramatic pressure reduction is caused by gas blowby which, in turn, fuels the spectacular visual signature characteristic of fallback, that

Figure 15. Breech and chamber pressure curves--tube S/N 24715

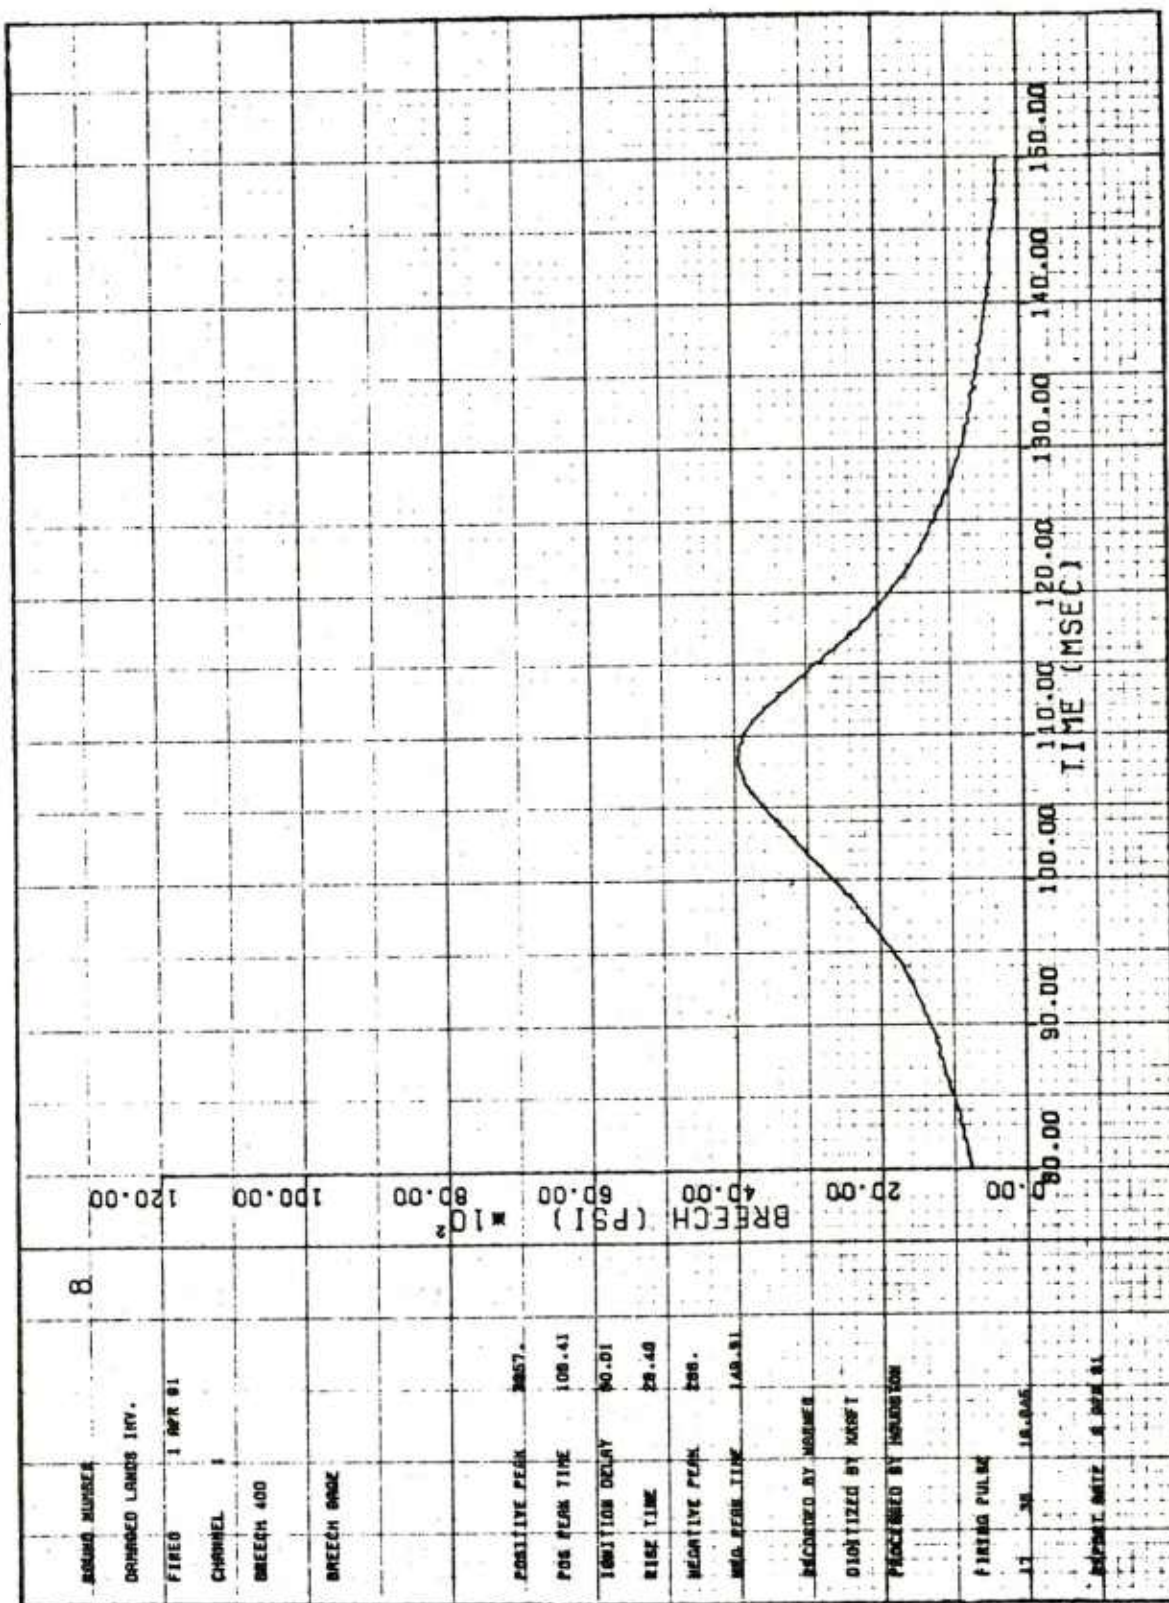
b. Breech--round 8

Figure 15. (cont)

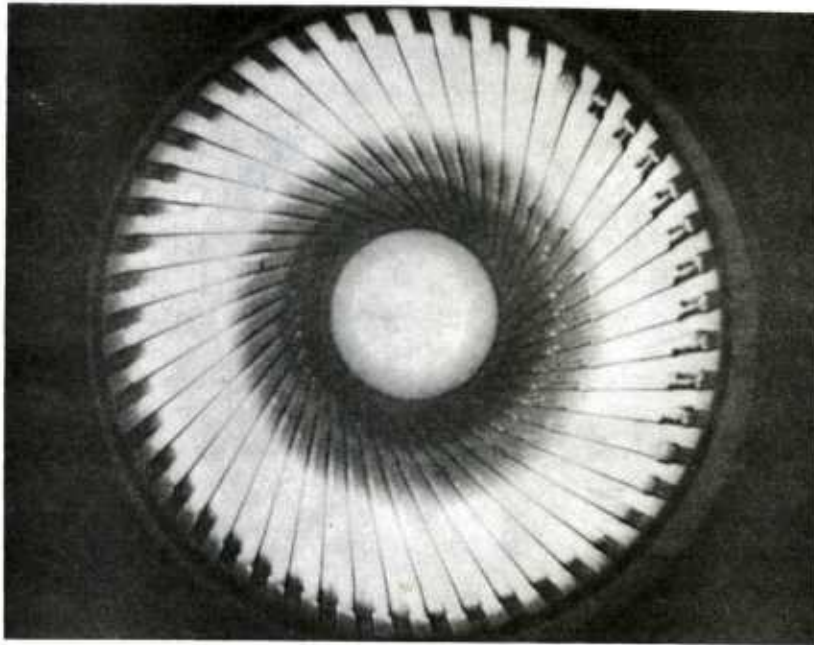
a. Origin of rifling general view after firing 458 rounds

Figure 23. M185 cannon tube S/N 25460 at start of degradation test

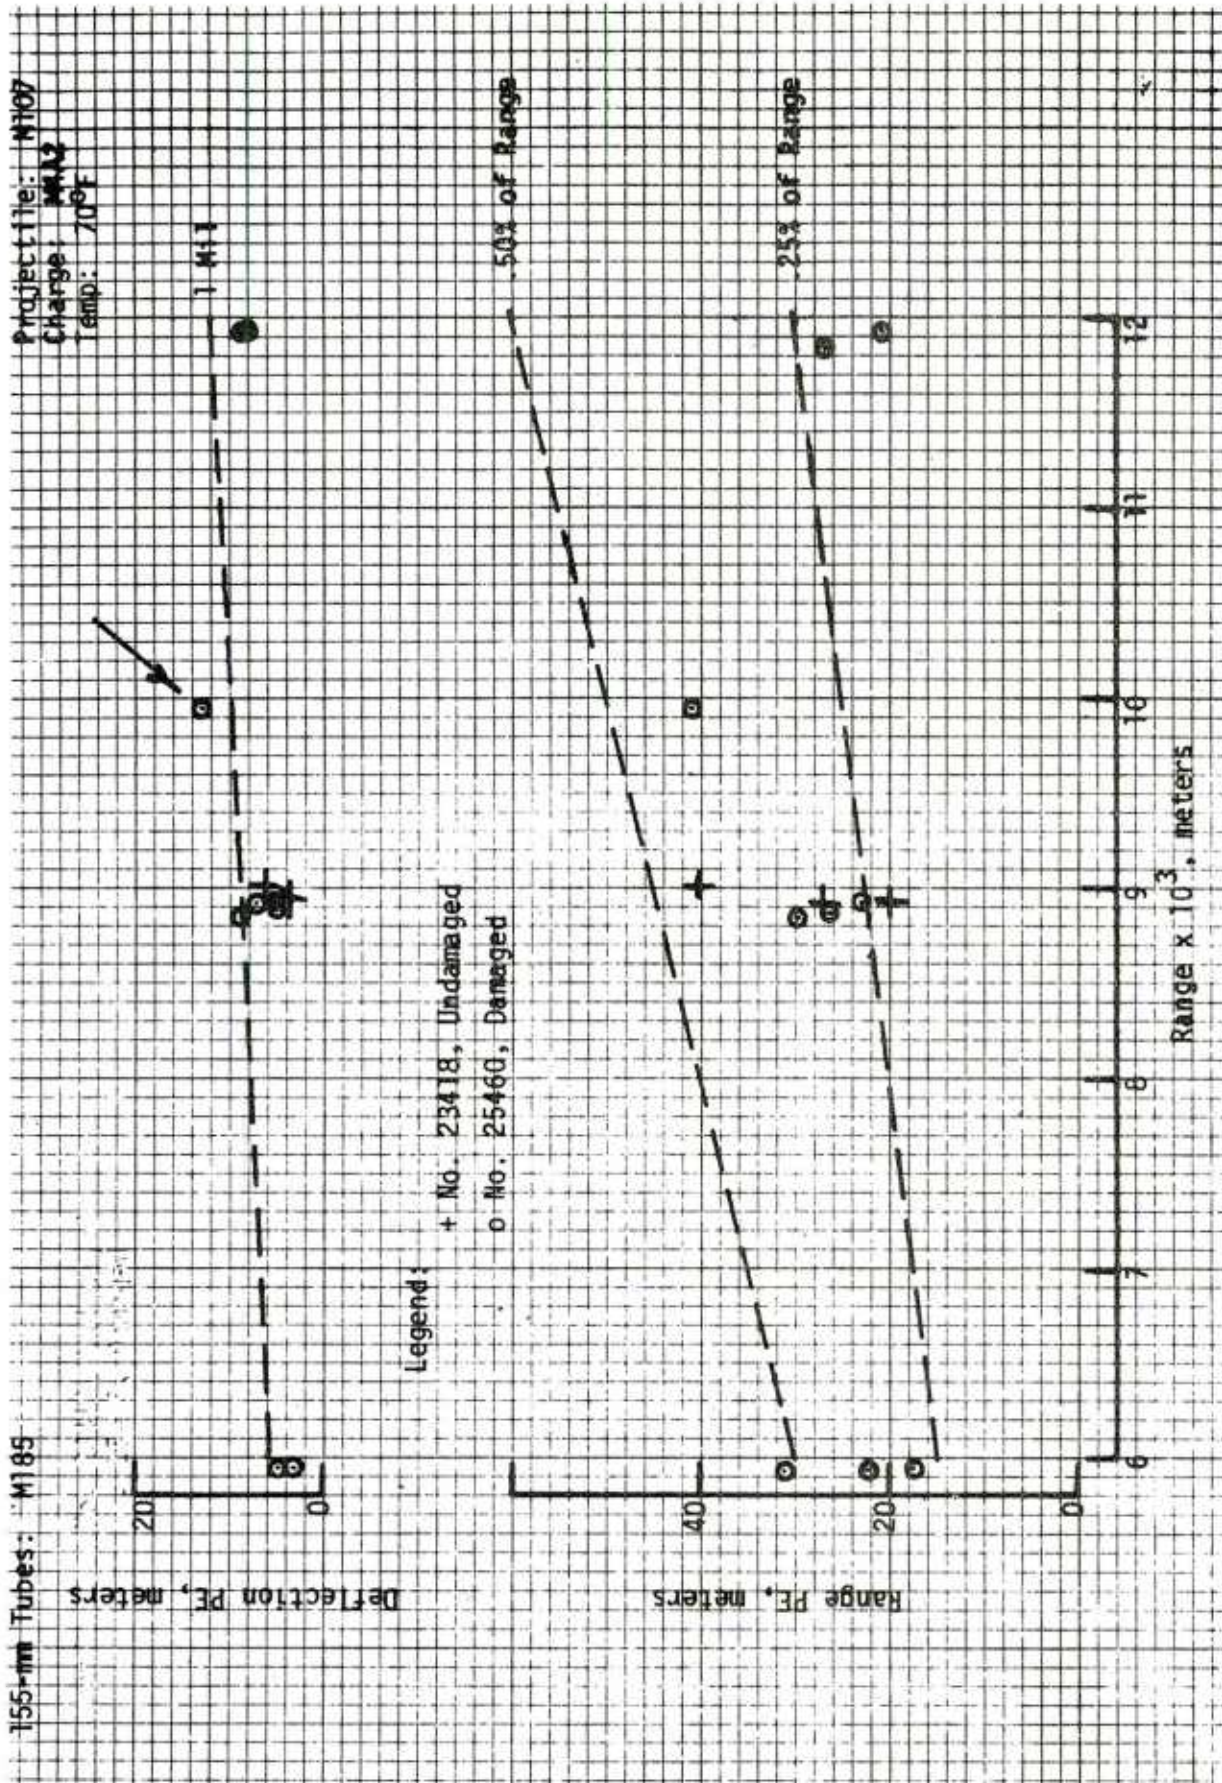
Figure 26. Range and deflection PE versus range

The range and deflection data collected during phases A and B were compared to the values published in firing table FT-155-AM-1. These comparisons are provided in tables 19 and 20. They show that the actual values from both the damaged and the undamaged tube firings proved in some cases better, and in some cases worse, than the predicted range and deflection values. There were, however, two cases in which acceptable norms were exceeded and both appeared in the damaged tube group. Specifically, the 6000-m series, with the M4A2 zone 7 charge, exceeded the probable error of 0.50% of range; and the 10,000 meter series, with the M4A2 zone 5 charge, exceeded the probable error of 1 mil in deflection. Figure 26 graphically depicts the probable error values received in both groups of firings (from damaged and undamaged groups) and their relationship to frequently applied criteria. The outliers are indicated with arrows. Plots of the aim point, impact coordinates, and the statistically generated center of impact for the 6000-, 9000-, 10,000-, and 12,000-m groups are given in figures 27 through 30. Special attention should be given to plots of the 9,000-m groups which provide a visual reference for comparing firings from a damaged tube with those from an undamaged tube.

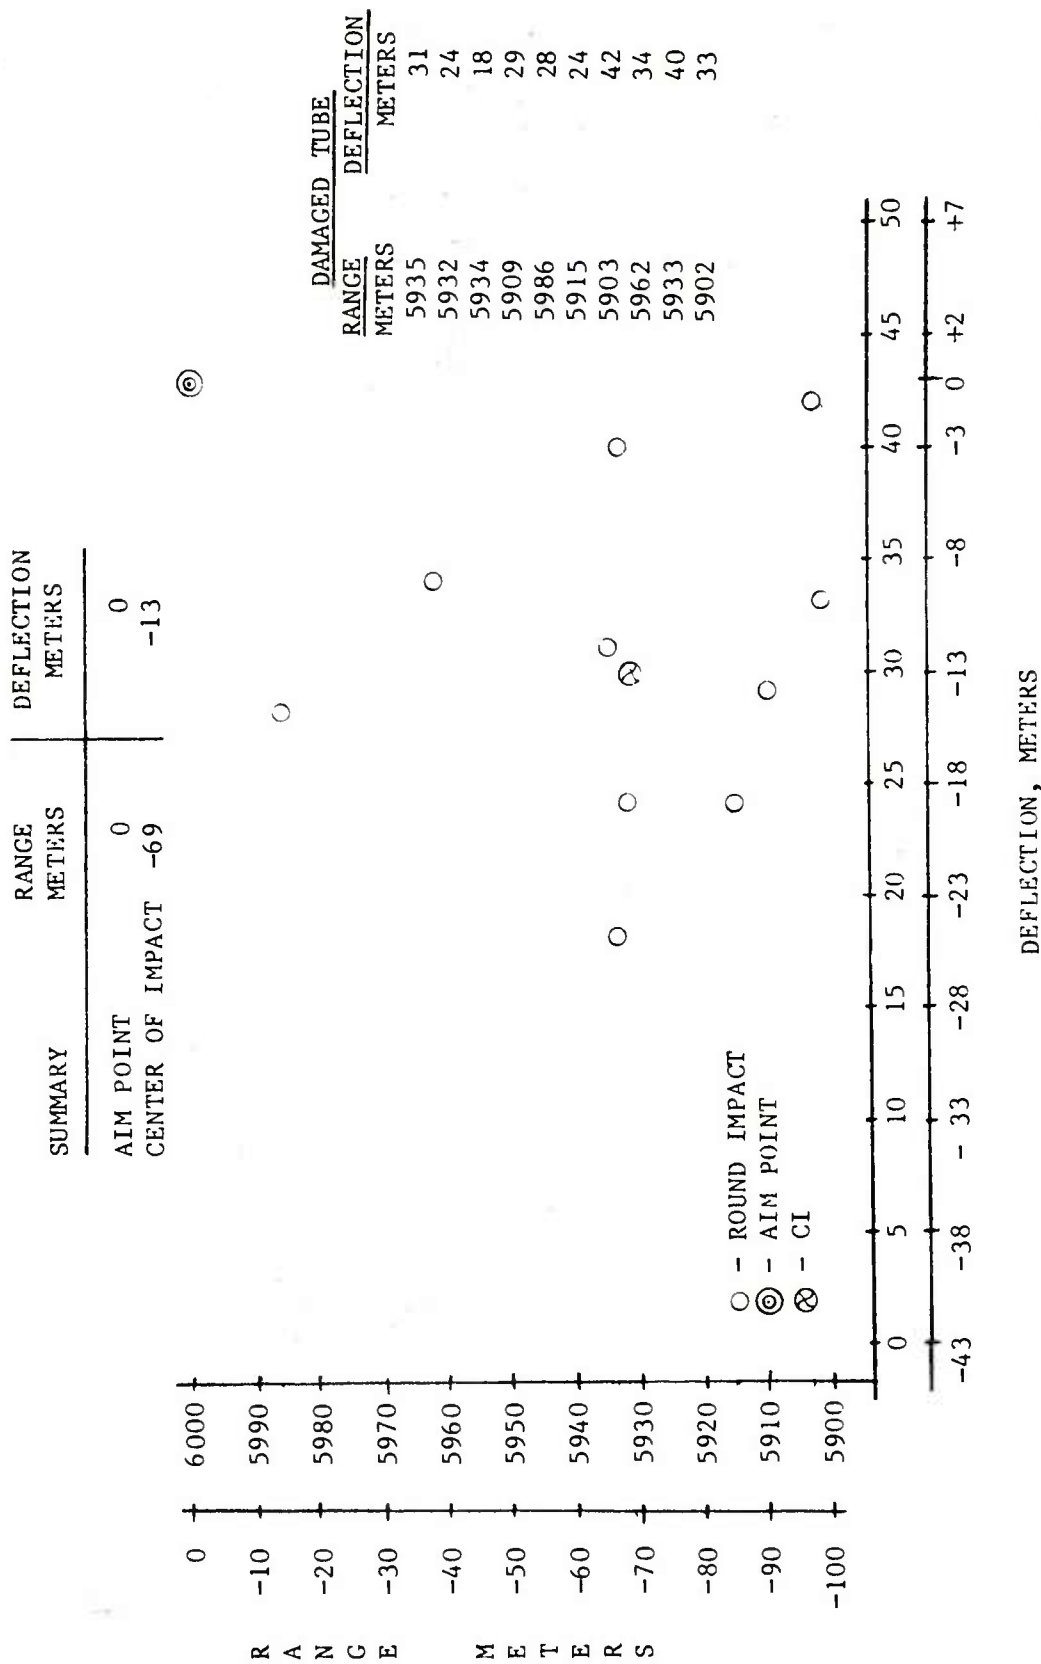
Figure 27. Range firings with damaged tube S/N 25460--6000 meters

SUMMARY	RANGE METERS	DEFLECTION METERS
AIM POINT	0	0
CENTER OF IMPACT	-85	-10

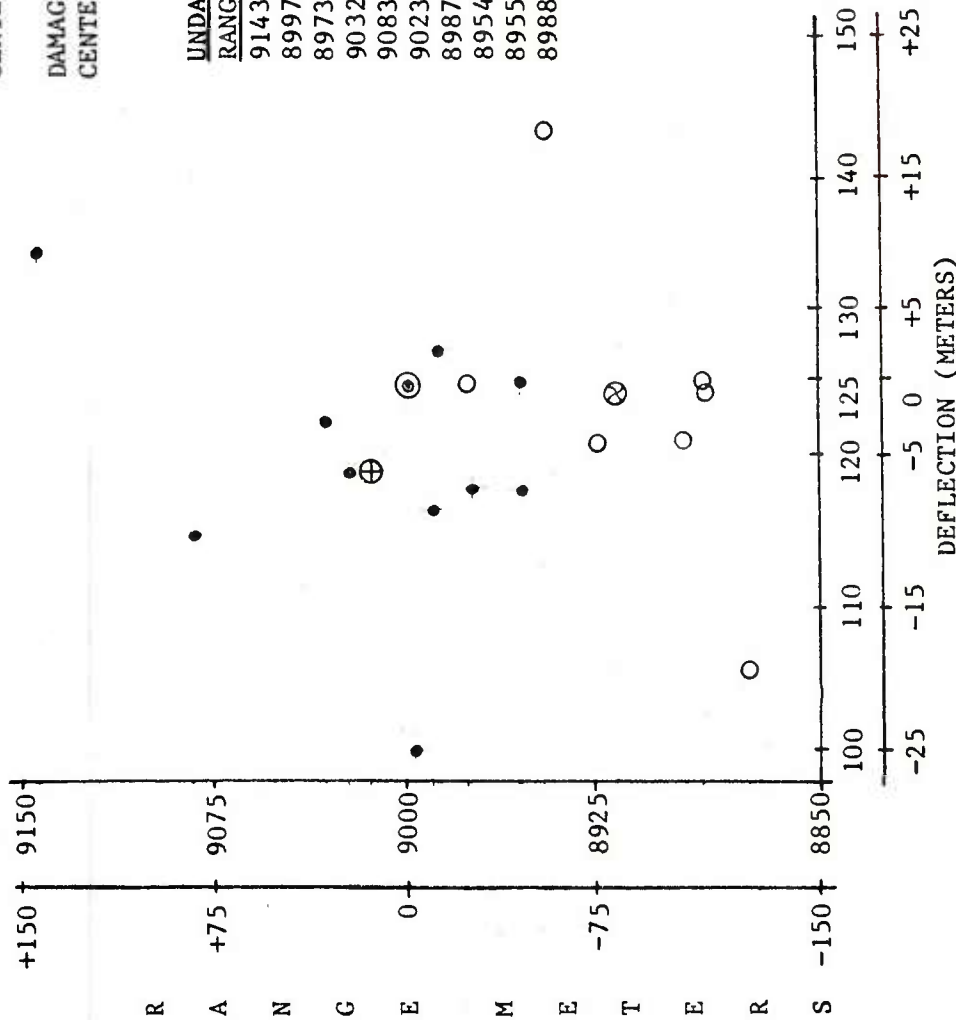
Figure 28. Comparison of range firings--undamaged tube S/N 25460 versus damaged tube S/N 25460--9000 meters

SUMMARY (METERS)	RANGE	DEFLECTION
AIM POINT	0	0
UNDAMAGED TUBE CENTER OF IMPACT	+14	-6
DAMAGED TUBE CENTER OF IMPACT	-83	-1

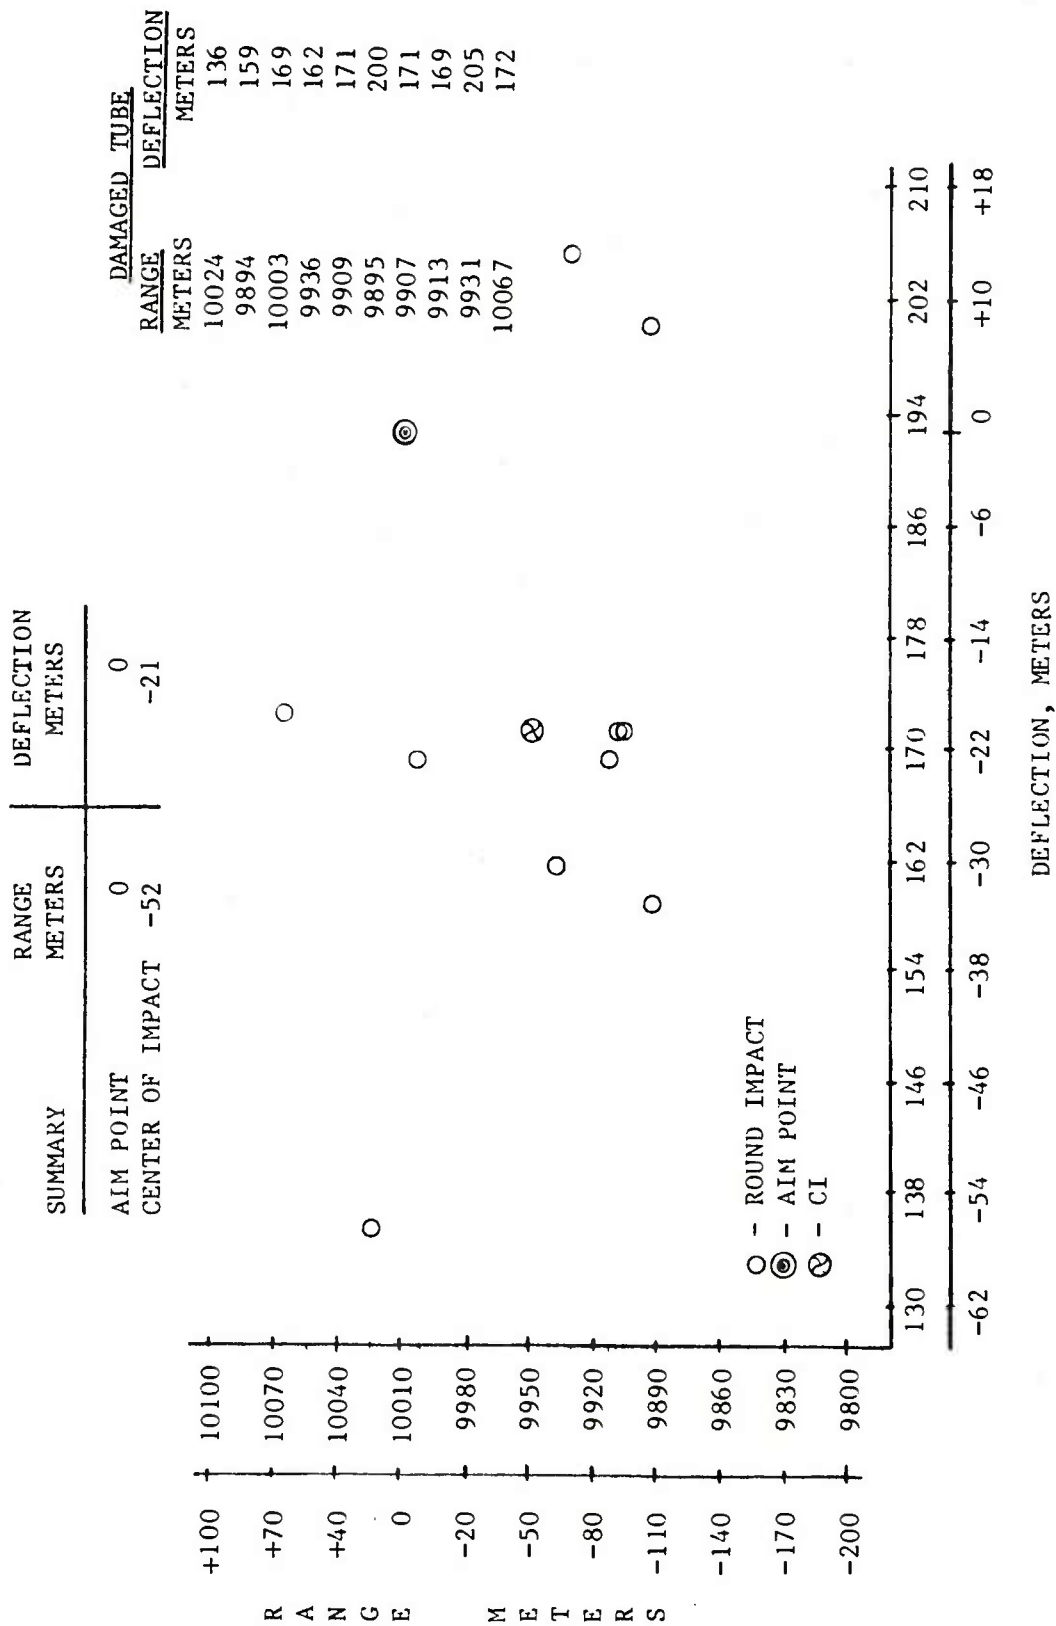
Figure 29. Range firings with damaged tube S/N 25460--10,000 meters

SUMMARY	RANGE METERS	DEFLECTION METERS
AIM POINT	0	0
CENTER OF IMPACT	-72	-36

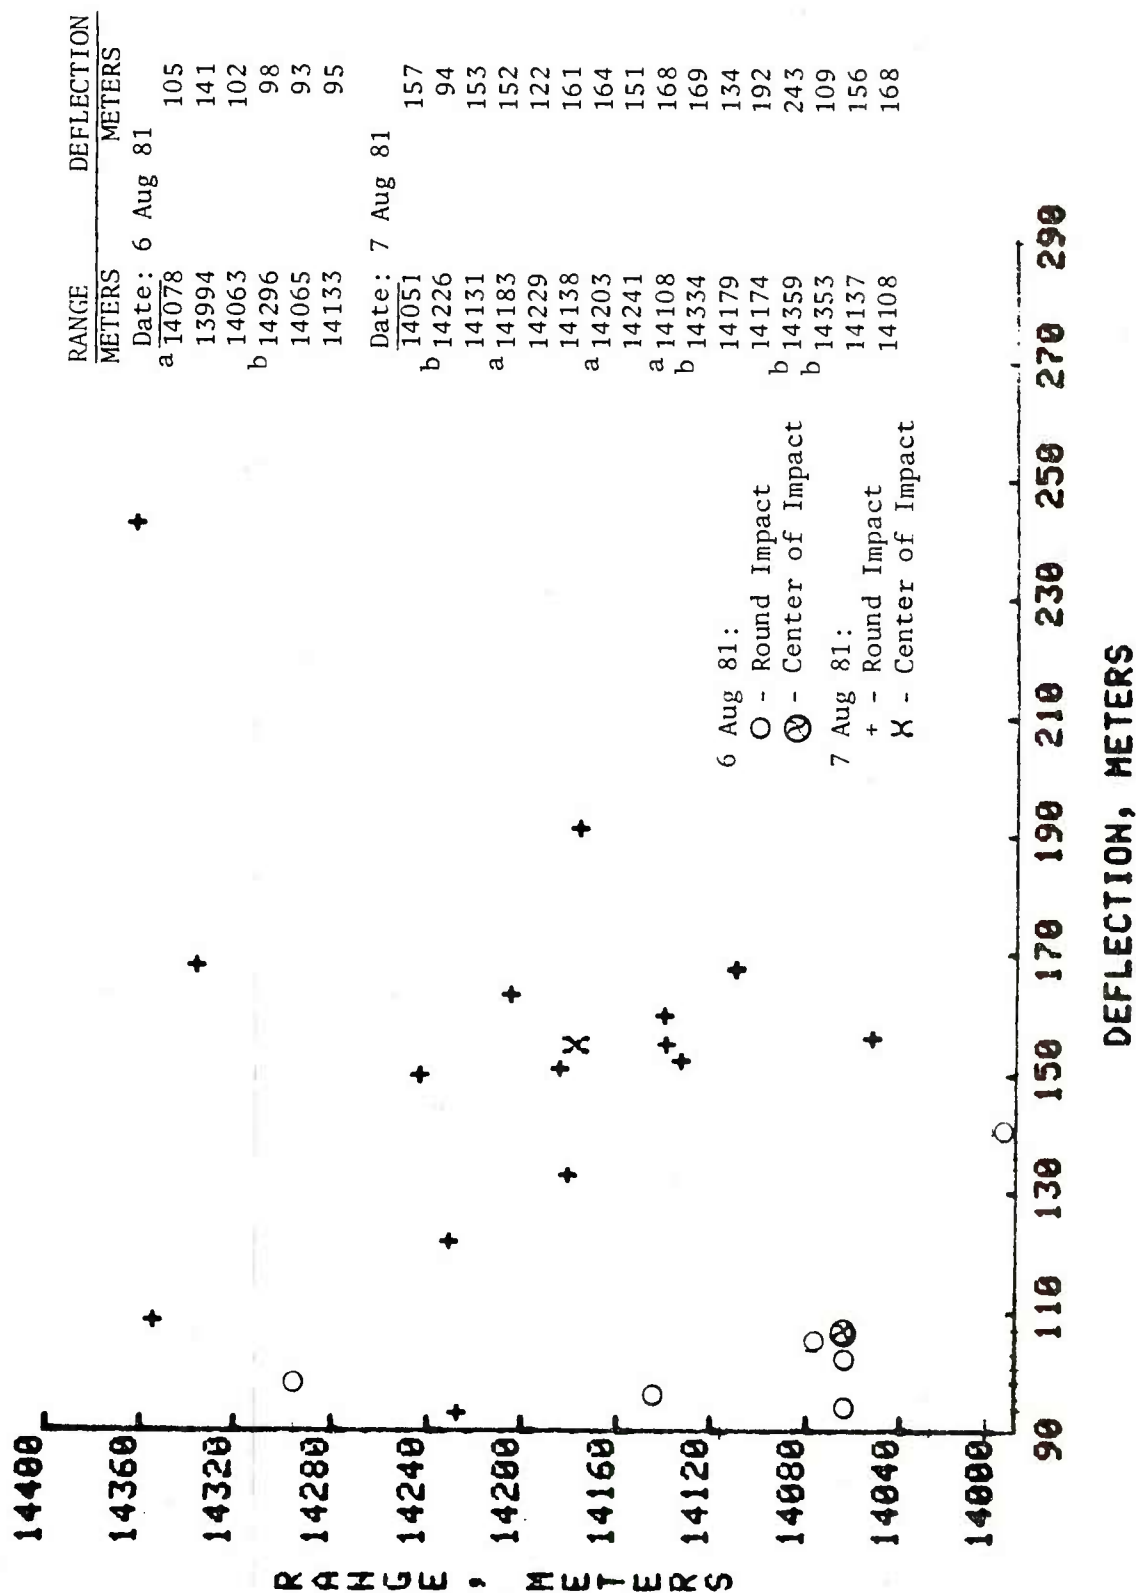
Figure 31. Range firings with damaged tube S/N 25460--M577 fuze and M483A1 projectile

The results of the M483 firings, presented in table 21, were compared with the published values in firing table FT-155-AN-1, "Table G: Supplementary Data for Projectile, HE, M483A1 and Fuze, MTSQ, M577." There is a variation from the firing table (FT) values of about 5 m in range probable error and 4 m in deflection probable error. The 6 August 1981 and 7 August 1981 firing groups are plotted (fig. 31). The unusual number of duds observed during testing prompted a follow-up investigation to learn the probable cause. The acceptance test record on M577 fuze lot no. BWV79L008-029 (ref 11, JPG Firing Record No. 79-1082) was requested from the Nuclear and Fuze Division of the Large Caliber Weapon Systems Laboratory (LCWSL). This record documented the firing of 20 rounds from a 155-mm howitzer. Of these, there were no outliers, offtimes, or duds. A review of peak chamber pressures, muzzle velocities, and spin rates by APG confirmed that the fuzes had been subjected to the required setback forces and spin rates for fuze arming. From this it was concluded that the most likely cause for the modifications was the type of spotting charge used and not the M577 fuze or the rifling damage in the M185 cannon.

a. IR times lost
 b. Round malfunctioned - no air burst
